**Investigation of 30-inch Pipeline
Rupture and Fire,
Trunkline Gas Company, in
Ship Shoal Block 90,
Off the Louisiana Coast**

U.S. Department of the Interior
Minerals Management Service
Gulf of Mexico OCS Regional Office

C. J. Schoennagel
F. V. Patton
W. D. Terrebonne

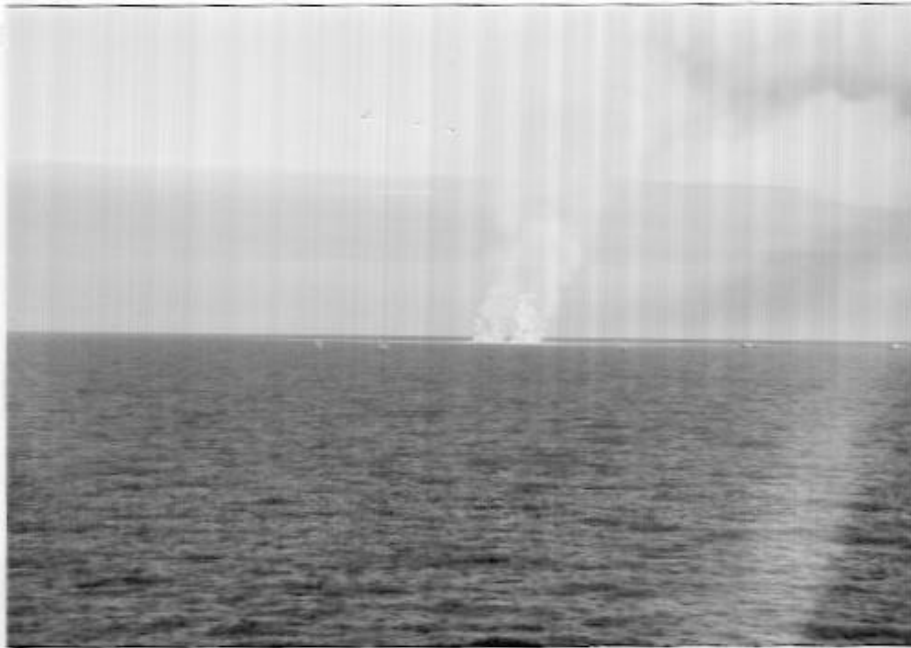
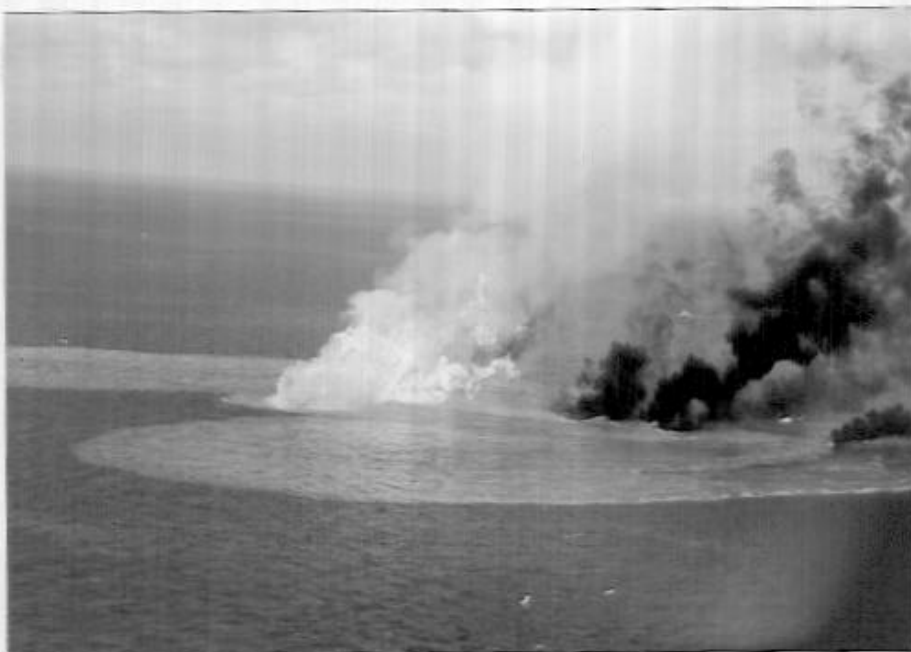
Photographs of Fire

Personnel from the MMS Houma District office flew to the area of the pipeline rupture shortly after it occurred, and photographed the resulting fire. (For photographs of fire, see attachment 1.) They then proceeded to the Ship Shoal Block 139 T-25 Platform, a valve and pipeline crossover platform operated by Trunkline, to ensure that the ruptured pipeline had been shut in.

On November 3, 1992, at approximately 7:45 a.m., the 30-inch gas pipeline ruptured at a point in Ship Shoal Block 90, in about 25 feet of water. The gas from the pipeline caught fire with flames rising several hundred feet above the water.

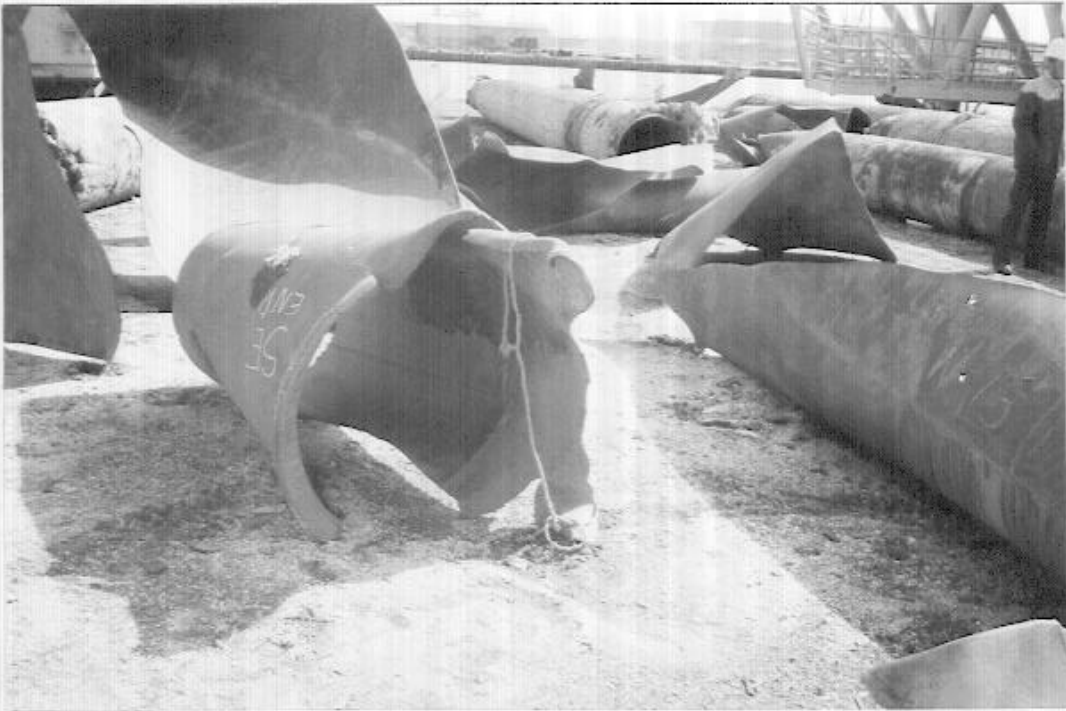
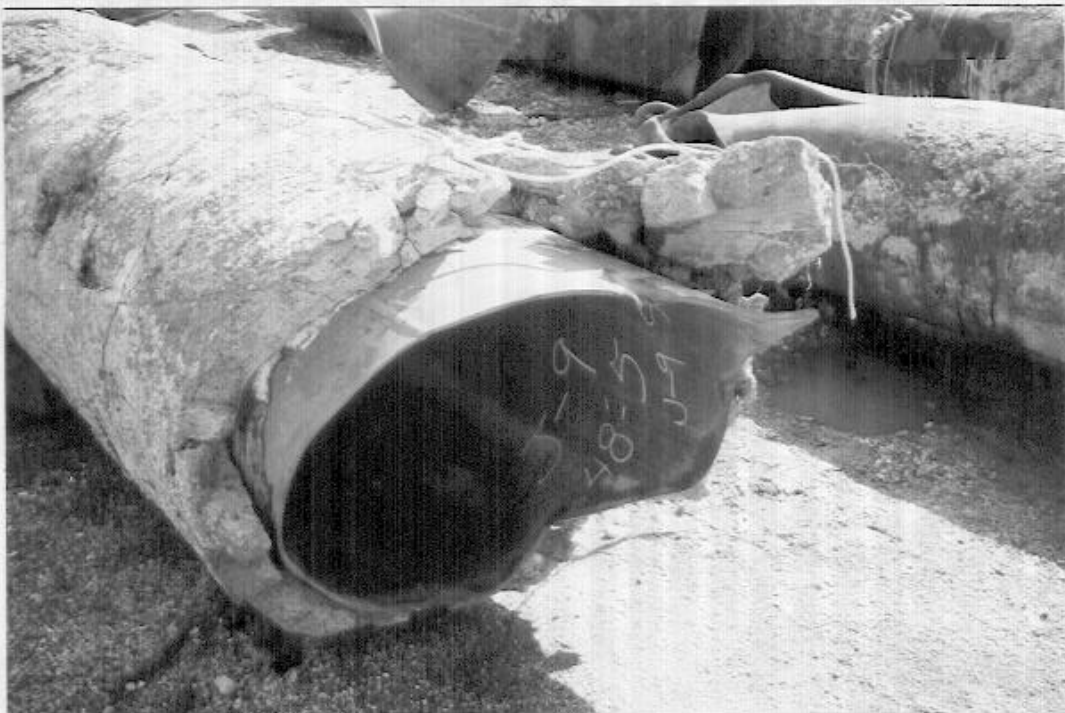
Photographs of Damaged Pipe

Investigative Panel members visited an Amelia, Louisiana, storage yard on November 13, 1992, to view the pieces of the ruptured pipeline recovered from the seafloor. (For photographs of ruptured pipeline, see attachment 2.) They also obtained information from personnel familiar with the accident.

The sidescan sonar data and Mesotech Equipment were utilized to locate and recover the damaged pipe. In all, 13 pieces of pipe, representing 386 feet of the 431 feet of pipe damaged, were recovered. The *DB-2* moved off location on November 11, 1992, and proceeded to a storage yard in Amelia, Louisiana, to offload the damaged pipe.

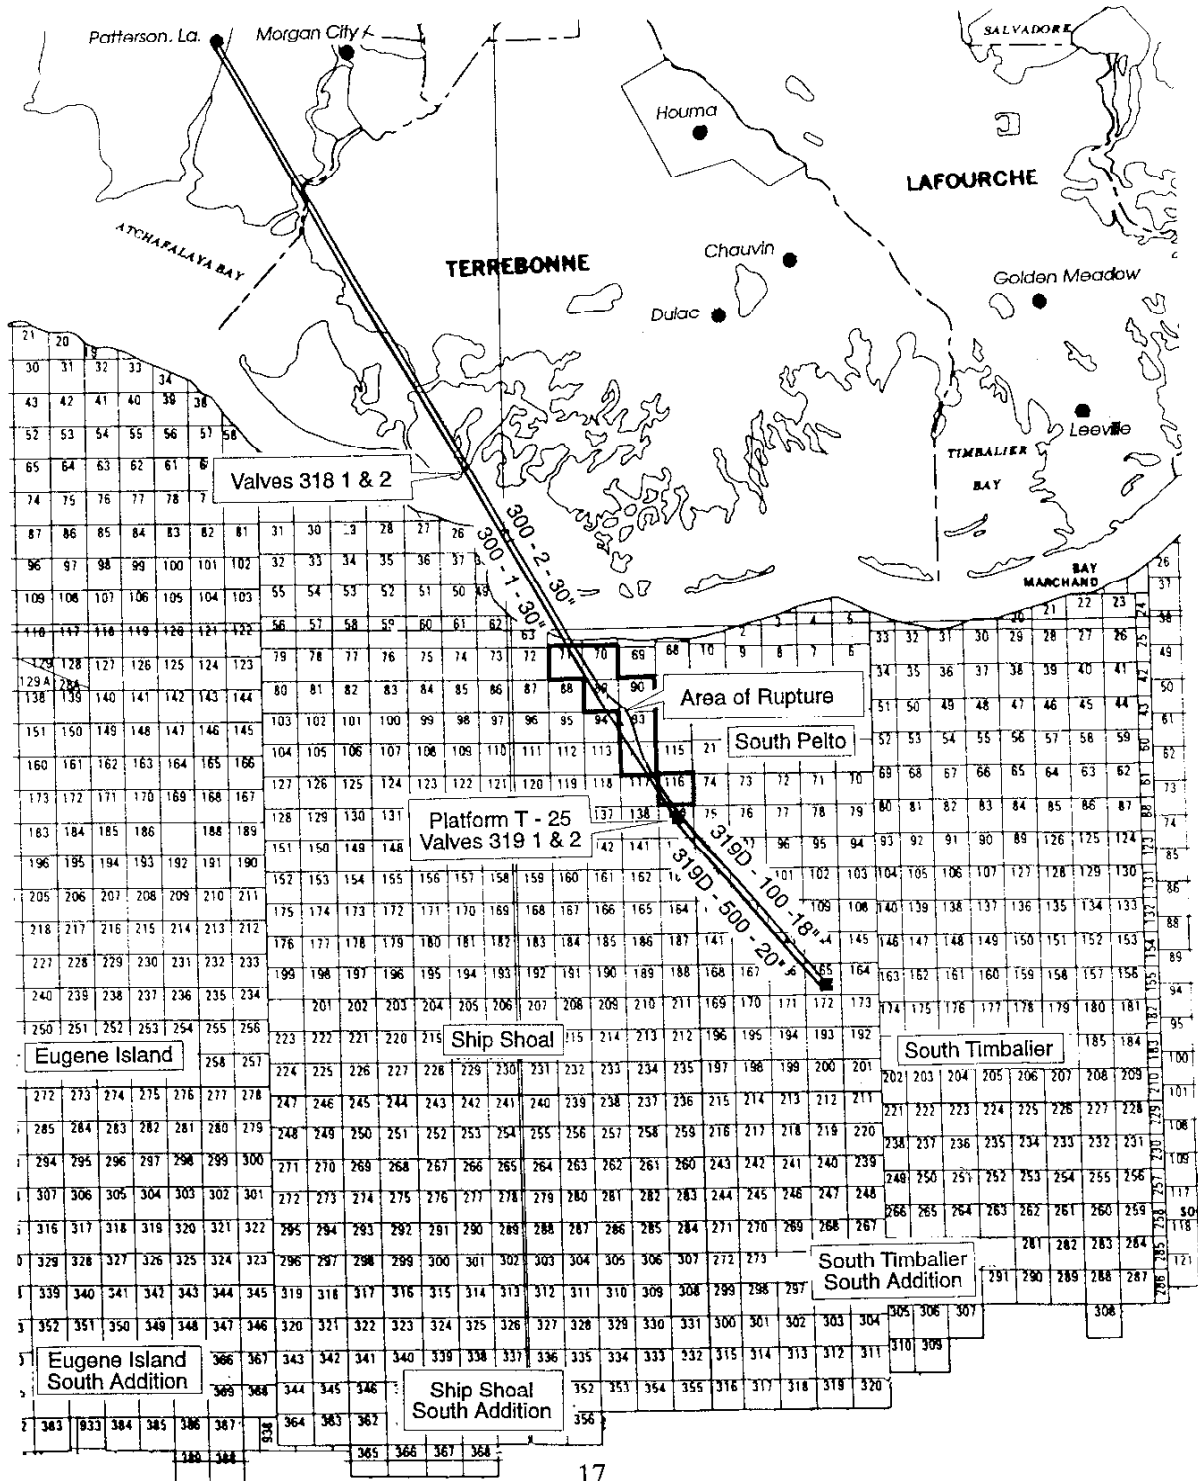
Schematic of the 30-inch Pipeline

Trunkline dispatched personnel at 8:10 a.m. to their T-25 platform and to Gate Valve 318, which is located at the beach, to check out the reported incident. (For schematic of the 30-inch pipeline, see attachment 3). At 8:15 a.m. Trunkline's personnel at Gate Valve 315, located at Patterson, had noticed a slight drop in pressure in Trunkline's 30-inch Gas Pipeline 300-2. By 8:30 a.m. personnel had closed Gate

At the time of the incident Gate Valve 319-2 was being repaired due to Hurricane Andrew damage. Therefore, the T-25 platform equipment that would shut in the pipeline in case of a line break was not in service.

The equipment that would shut in the pipeline at Gate Valve 318-2 was set at 700 psig. Since the pipeline pressure stayed above the low pressure setting, the valve did not close automatically.

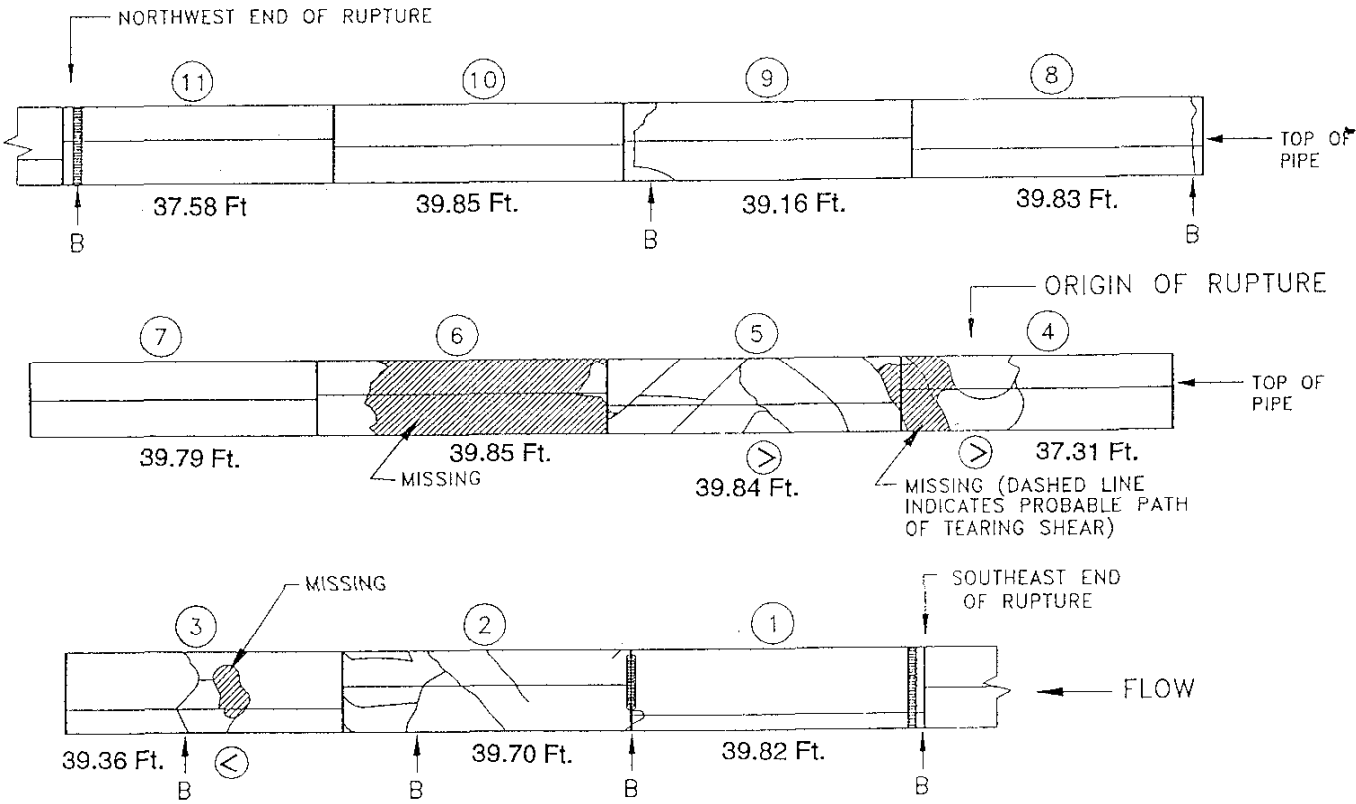
Schematic of 11 Joints of Damaged Pipe

The damaged pipe was sent to a laboratory for analysis. The 13 pieces of pipe, representing 11 joints of the initial pipeline affected by the incident, were repositioned as they were prior to the rupture so that an attempt could be made to locate the origin of the failure. (For schematic of 11 joints damaged pipe, see attachment 4.)

The origin of the failure was identified as a fracture in a piece of Joint No. 4 of the recovered pipe. (For photograph of origin piece of Joint No. 4, see attachment 5.) A large dent, which is continuous across the fracture, exists on the top of the pipe, indicating mechanical damage such as that caused by a large, blunt object being dropped from above or dragged over the top.

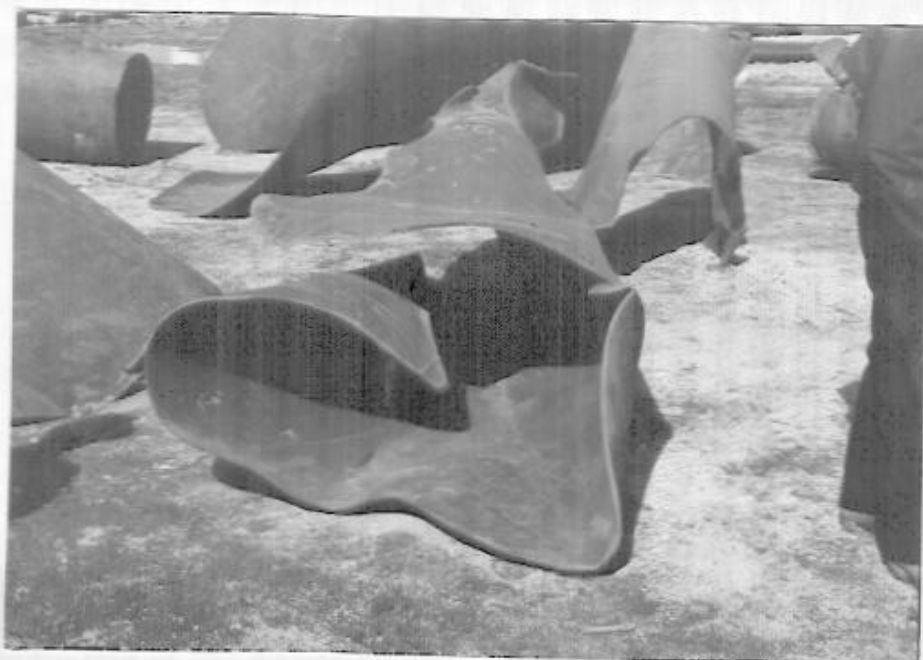
Photographs of Origin Piece of Joint No. 4 and Barnacles on the Concrete Coating

A possible cause of origin of the pipeline rupture is that the pipeline was struck and weakened by something during the passage of or subsequent to Hurricane Andrew. The pipeline operated at higher pressures prior to its shut-in for Hurricane Andrew than at the pressure at which it failed.

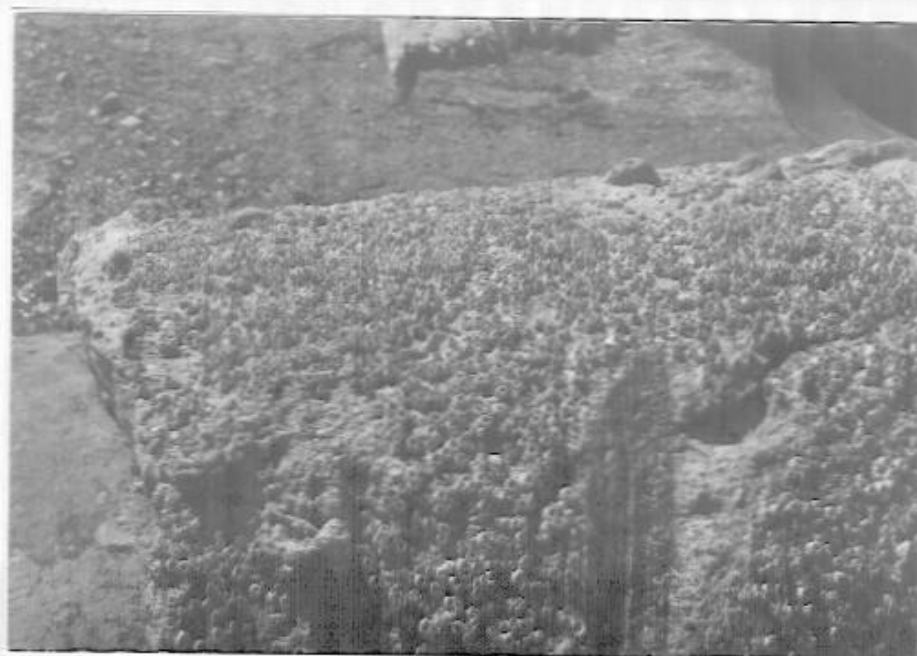
Photographs of Barnacles on the Concrete Coating

Barnacles were attached to both the concrete coating of pieces of the recovered pipe and to the coal-tar coating in the vicinity of the identified origin in Joint No. 4. (For photograph of barnacles on the concrete coating, see attachment 5.) The concrete coating was missing from a large intact portion of Joint No. 4 and, at the origin location of Joint No. 4, the coal-tar coating was also missing.

1. The segment of pipeline in the vicinity of the origin may have been unburied, as indicated by the barnacles on both the cement coating and coal-tar coating.
2. The segment of pipeline in the vicinity of the origin could have become unburied during the passage of Hurricane Andrew. The segment of pipeline unburied in the Ship Shoal Block 93 area was 145 feet in July 1992, and 793 feet in September 1992, after the passage of Hurricane Andrew.

1. All pipelines in an area where a major hurricane has passed should be hydrostatically tested prior to being put back into service.
2. All pipelines in water depths less than 200 feet should be surveyed every five years or after the passage of a major hurricane, if the pipelines are in the area of passage, to ensure that the pipelines have not become exposed above the seafloor. A copy of the survey should be submitted to the MMS along with a plan to rebury or re-cover the pipeline if it has become exposed.
